**FEDERAL
CONSERVATION CORP.**

Infrared Inspection Report

The following report outlines the findings of the infrared inspection performed within the living space of ,, of ,,. Deficiencies in the thermal and pressure boundaries were located in both the basement and first floor of the home. In order of greatest potential; the attic, exterior wall cavities, rim joist, and door seals, should be targeted for home performance upgrades to improve efficiency and improve occupant comfort.

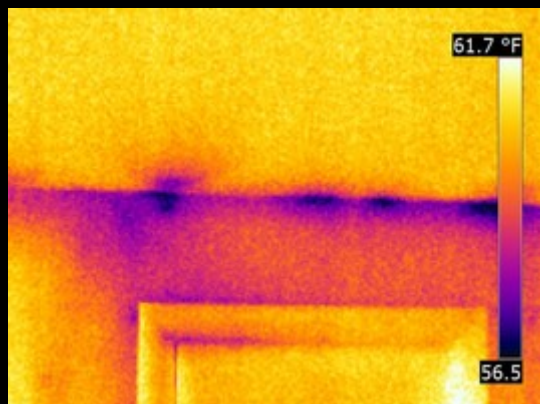
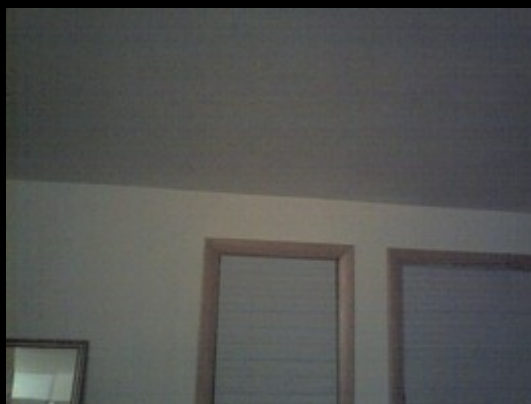
Image Number:	778
Location:	Basement Living Area
Description/Findings:	Air leakage observed from rim joist
Suggestions:	Seal and insulate rim joist

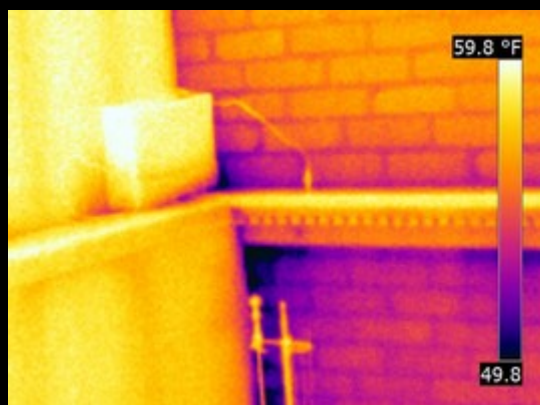
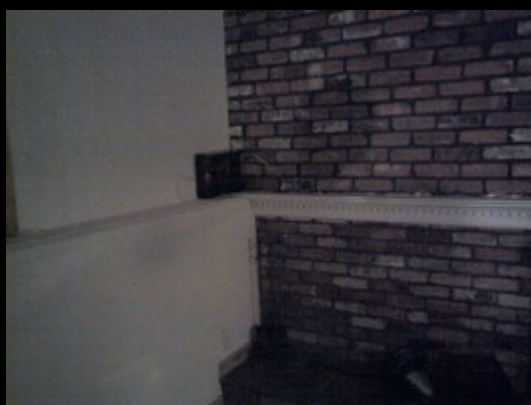
Image Number:	782
Location:	Basement Living Area
Description/Findings:	Air leakage observed at joint where brick meets Sheetrock wall
Suggestions:	Caulk/seal all joints

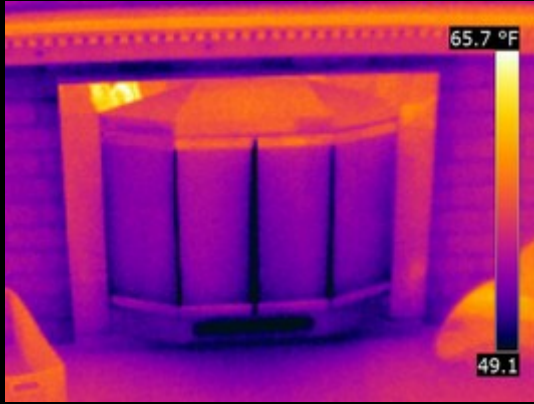
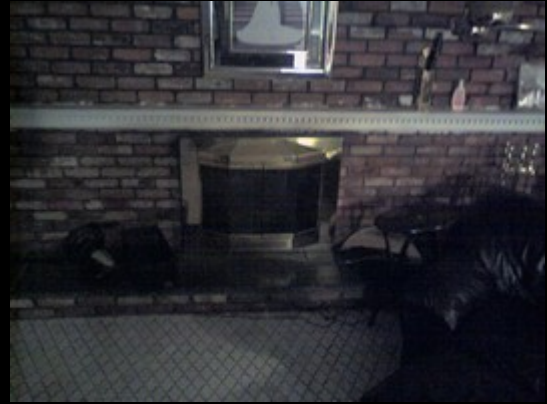
Image Number:	786
Location:	Basement Living Area
Description/Findings:	Air leakage observed from fireplace
Suggestions:	Repair flue seal or install inflatable balloon to reduce air leakage from chimney

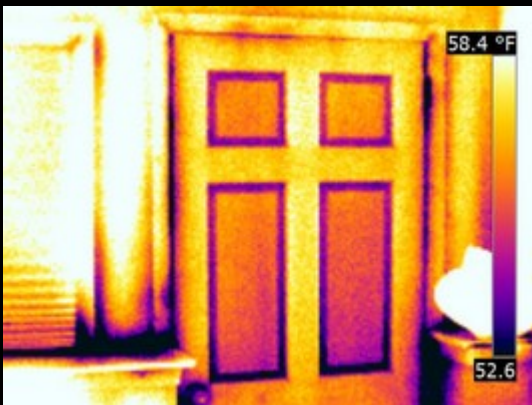
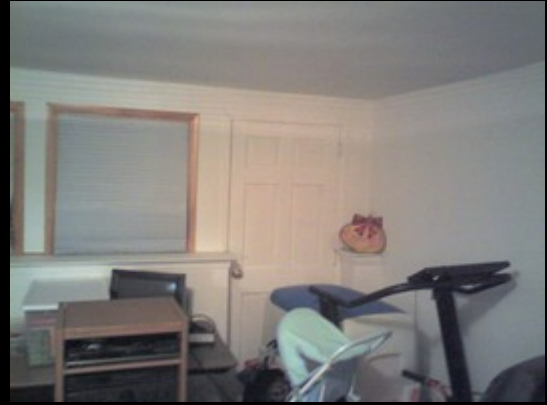
Image Number:	784
Location:	Basement Living Area
Description/Findings:	Air leakage observed around door, window frames, and molding
Suggestions:	Replace door weatherstripping Caulk/seal all joints

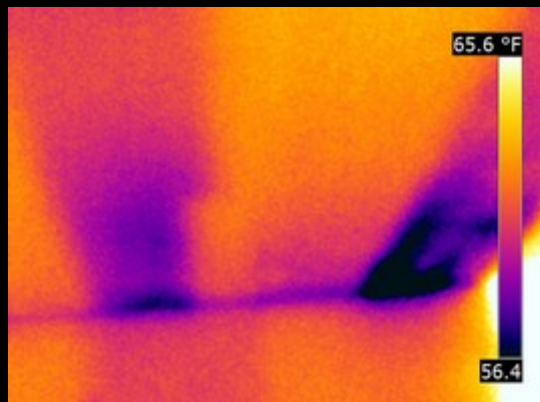
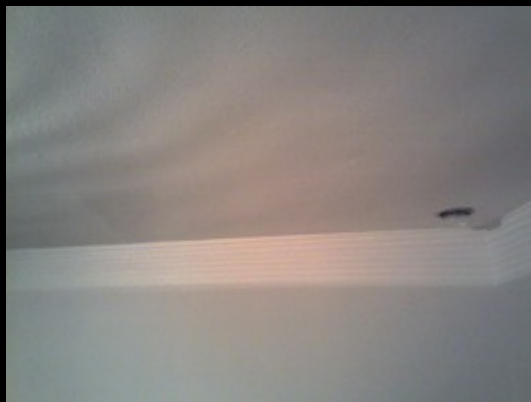
Image Number:	798
Location:	Basement Living Area
Description/Findings:	Heat loss and air movement observed in ceiling and wall cavities
Suggestions:	Seal rim joist and insulate exterior walls Repair broken exhaust flappers at exterior of home

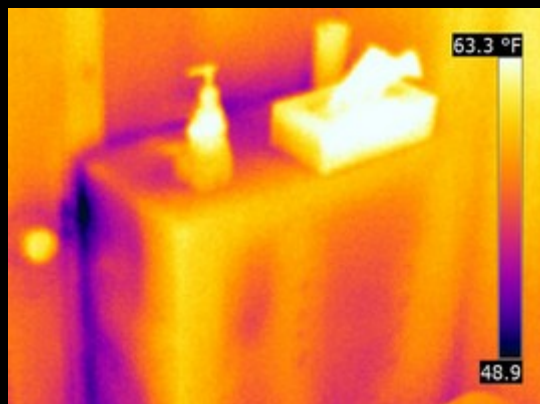
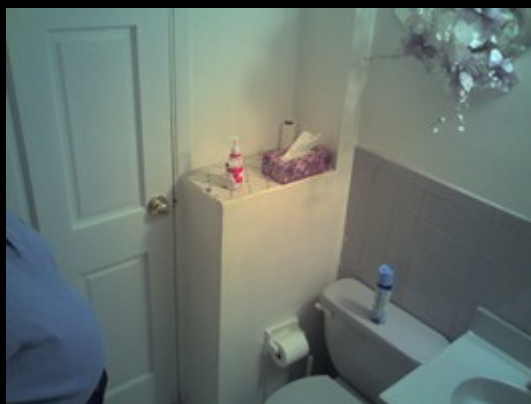
Image Number:	826
Location:	Basement Bathroom
Description/Findings:	Uninsulated wall cavity
Suggestions:	Insulate exterior wall

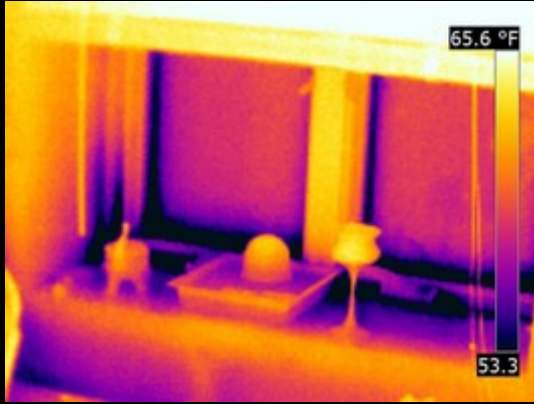
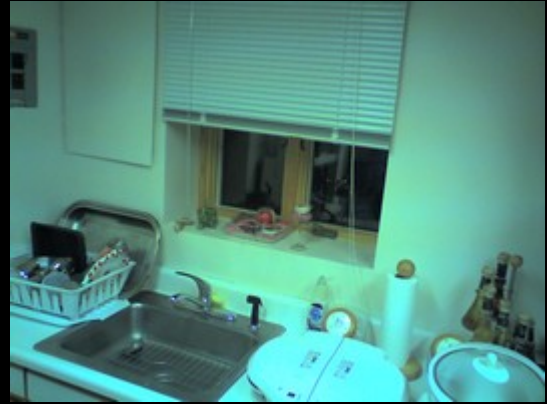
Image Number:	828
Location:	Basement Kitchen Area
Description/Findings:	Uninsulated wall area Air leakage from window frame
Suggestions:	Insulate exterior wall and window sill area Caulk window molding

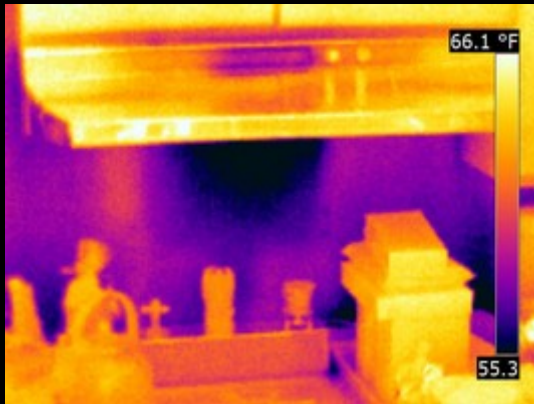
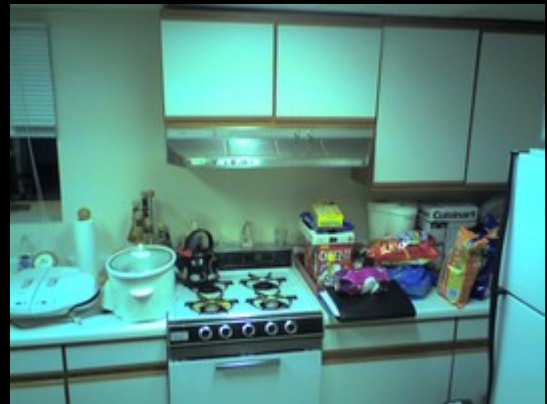
Image Number:	836
Location:	Basement Kitchen Area
Description/Findings:	Air leakage from range hood Uninsulated wall cavity
Suggestions:	Seal exterior exhaust flapper Insulate exterior wall

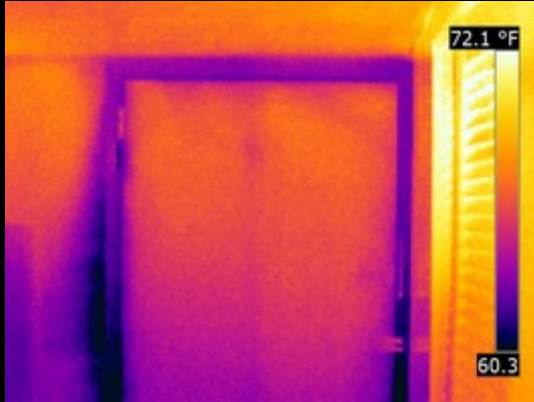
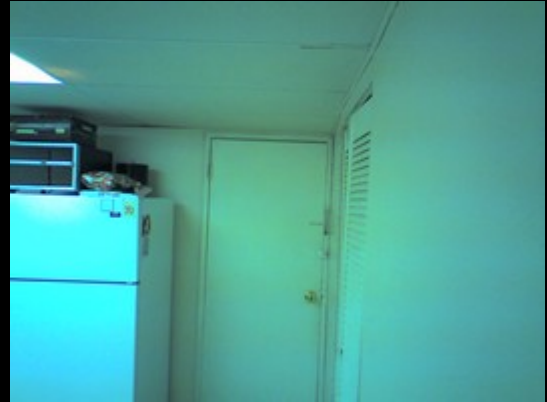
Image Number:	840
Location:	Basement Kitchen Area
Description/Findings:	Significant air leakage from exterior kitchen door
Suggestions:	Replace weatherstripping

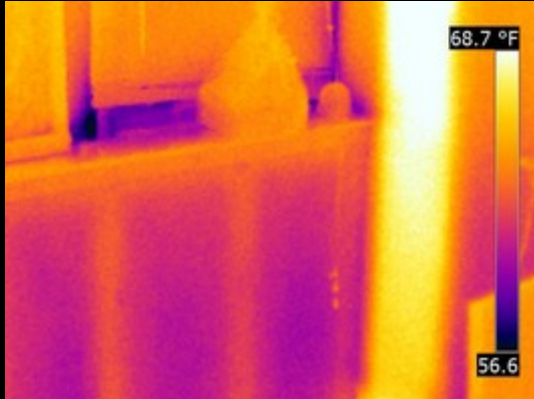
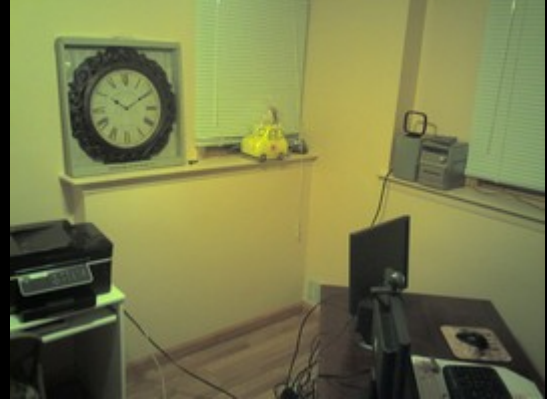
Image Number:	842
Location:	Basement Office Area
Description/Findings:	Uninsulated exterior walls Uninsulated duct within exterior wall cavity
Suggestions:	Insulate exterior walls If possible: re-route duct work to an interior wall

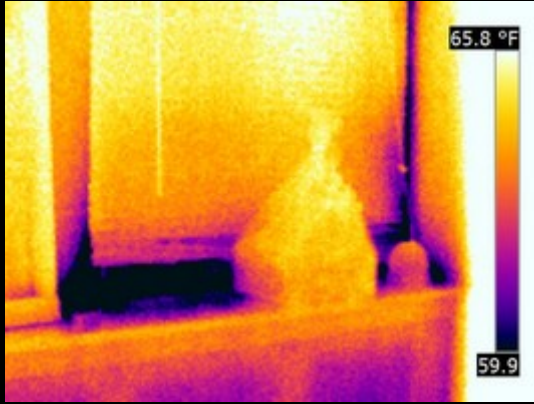
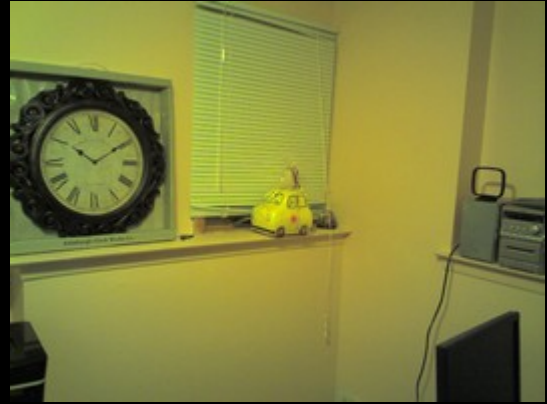
Image Number:	844
Location:	Basement Office Area
Description/Findings:	Significant air leakage from window
Suggestions:	Check seals and caulk molding

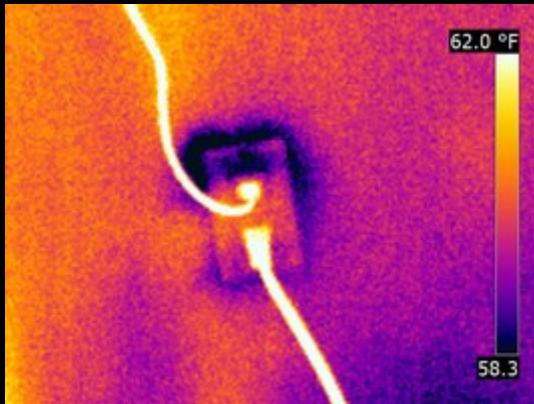
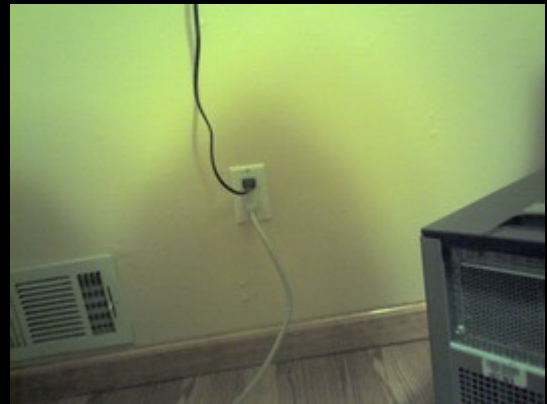
Image Number:	852
Location:	Basement Office Area
Description/Findings:	Air leakage from electrical socket located on exterior wall
Suggestions:	Insulate exterior walls Install socket gasket

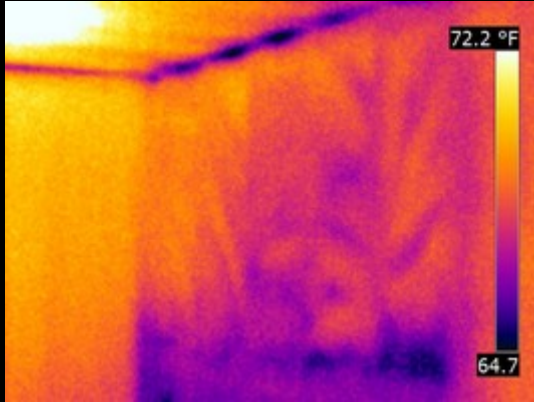
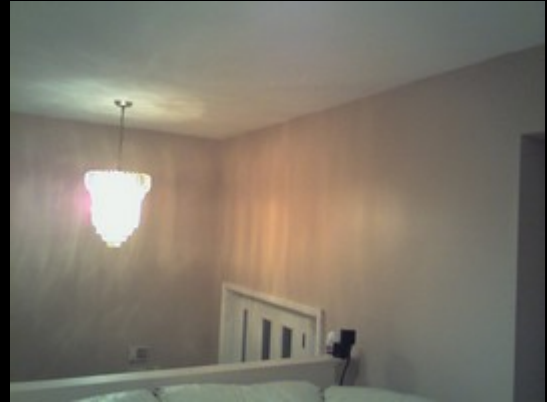
Image Number:	856
Location:	1 st Floor Living Area
Description/Findings:	Inadequate insulation above front door Wind-Washing from attic soffit vents
Suggestions:	Insulate exterior walls Install baffling in attic

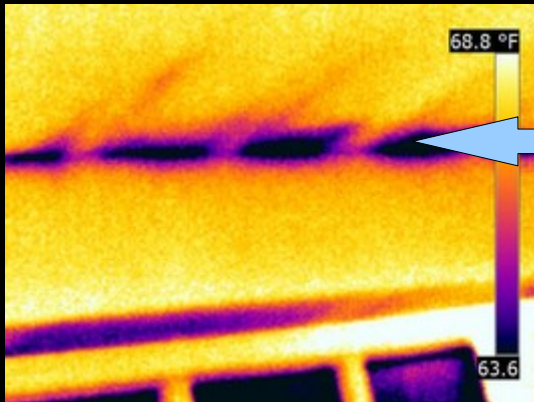
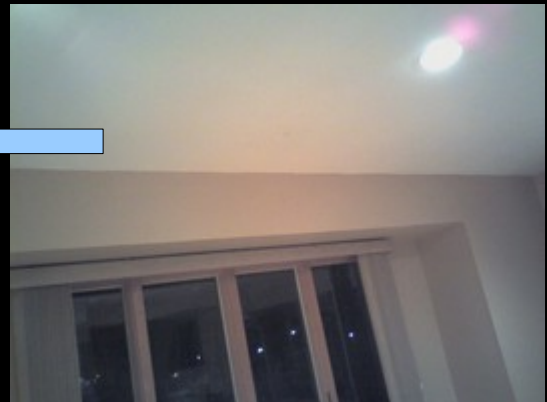
Image Number:	864
Location:	1 st Floor Living Area
Description/Findings:	Wind-Washing from attic soffit venting
Suggestions:	Install baffling in attic to properly direct attic ventilation

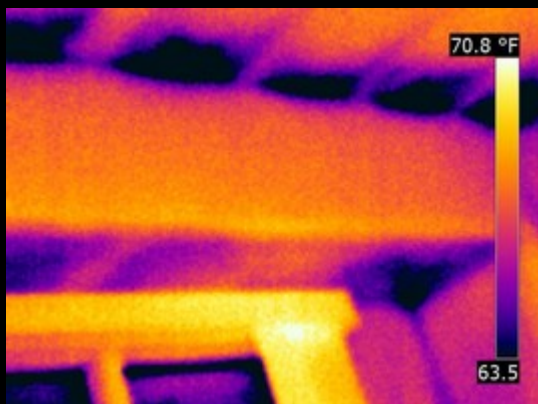
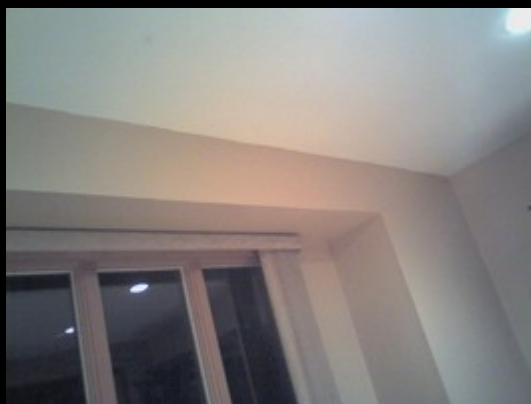
Image Number:	866
Location:	1 st Floor Living Area
Description/Findings:	Inadequate/Missing insulation in window soffit area
Suggestions:	Insulate exterior walls and window soffit

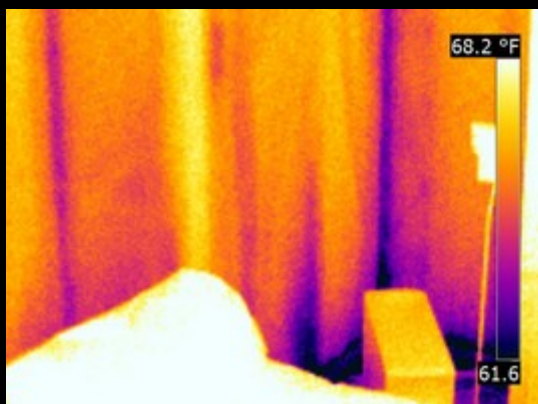
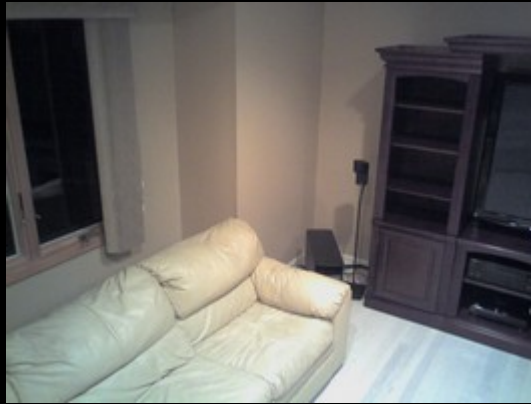
Image Number:	872
Location:	1 st Floor Living Area
Description/Findings:	Inadequate/Missing insulation in exterior walls Air infiltration from rim joist area (bottom)
Suggestions:	Insulate exterior walls Seal rim joist

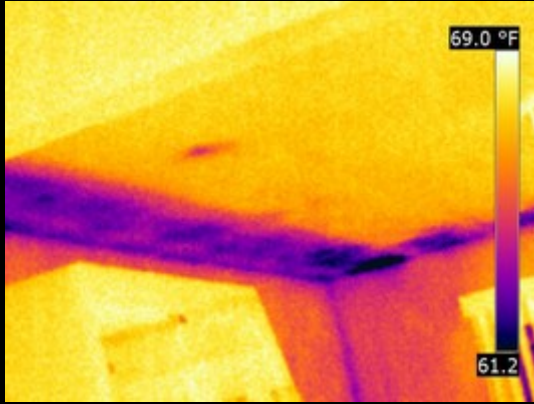
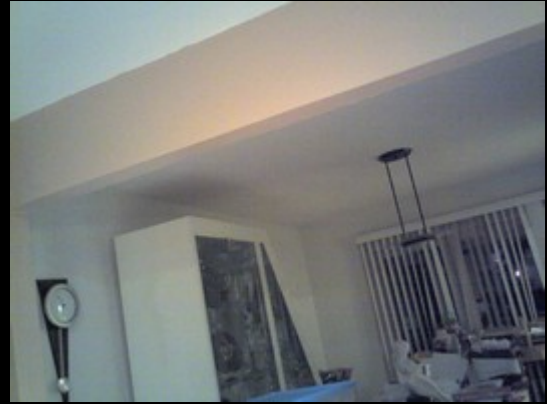
Image Number:	878
Location:	1 st Floor Dining Area
Description/Findings:	Rafter cavity completely missing insulation
Suggestions:	Air seal and insulate attic flat

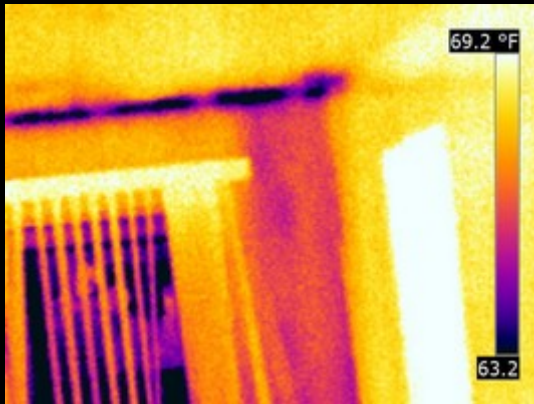
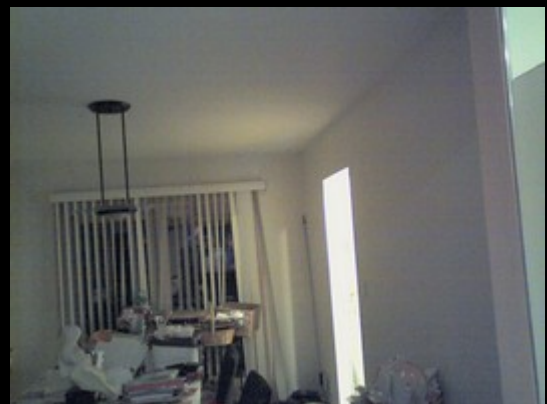
Image Number:	880
Location:	1 st Floor Dining Area
Description/Findings:	Inadequate/Missing insulation in exterior wall
Suggestions:	Insulate exterior walls

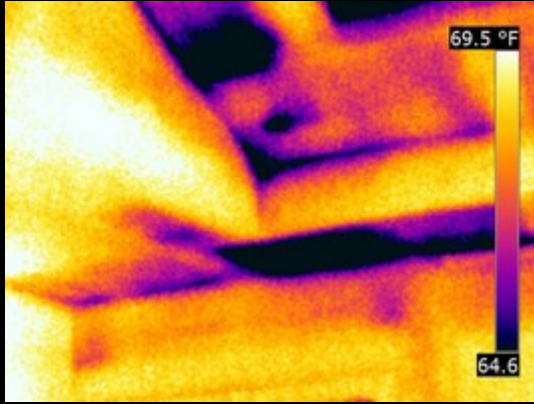
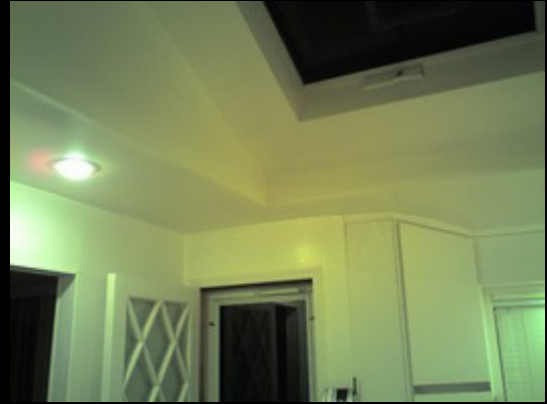
Image Number:	894
Location:	1 st Floor Kitchen Area
Description/Findings:	Missing and inadequate insulation observed in cathedral ceiling areas
Suggestions:	Insulate and encapsulate knee wall space bordering skylight

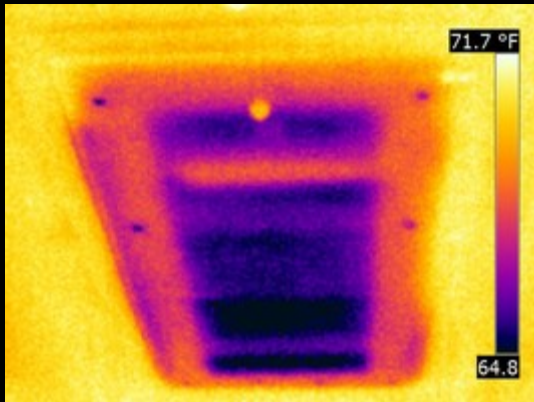
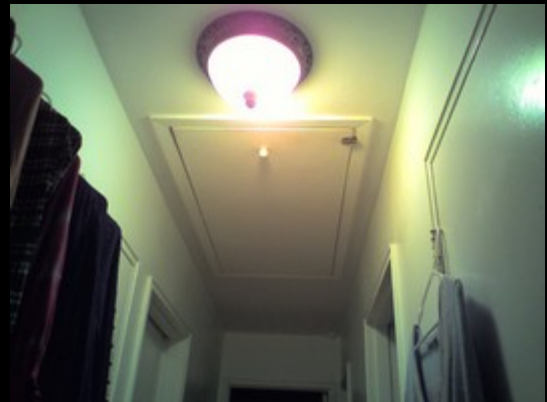
Image Number:	896
Location:	1 st Floor Hallway
Description/Findings:	Uninsulated pull-down attic staircase
Suggestions:	Install an insulated pull-down staircase or “Tent” to seal and insulate stairway

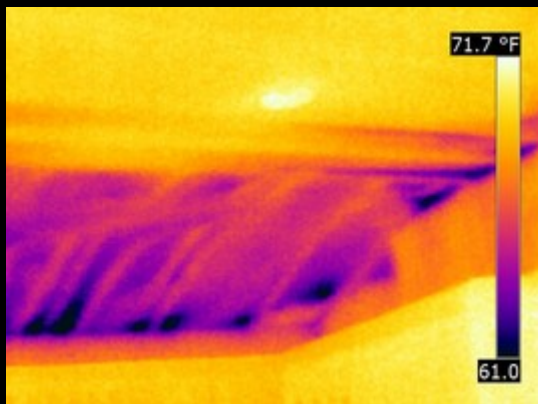
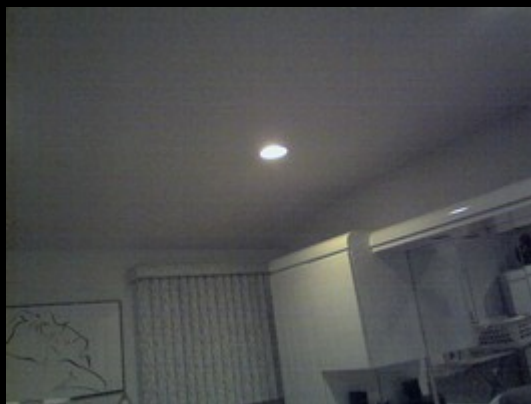
Image Number:	904
Location:	1 st Floor Master Bedroom
Description/Findings:	Slanted ceiling area with poor insulation and significant air leakage
Suggestions:	Insulate ceiling area and correct ventilation

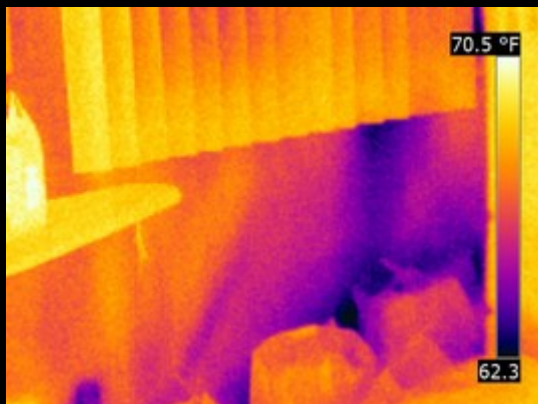
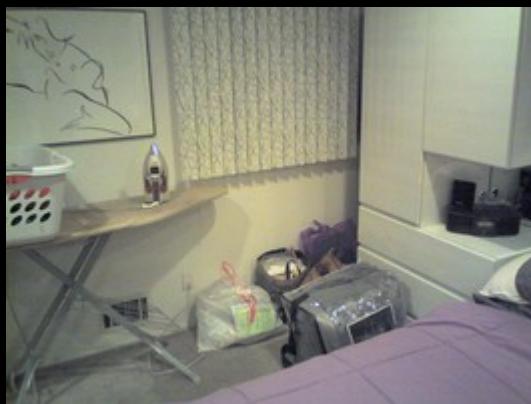
Image Number:	908
Location:	1 st Floor Bedroom
Description/Findings:	Significant air leakage from window
Suggestions:	Check window seals and caulk window molding

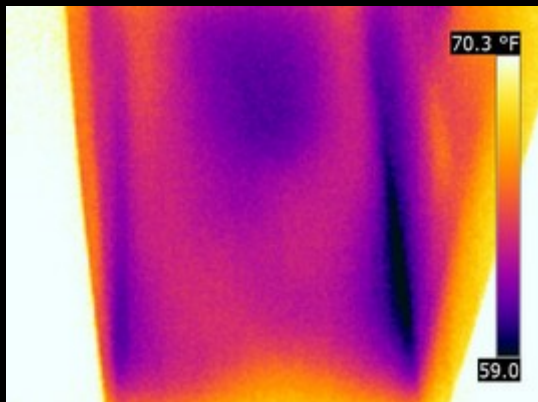
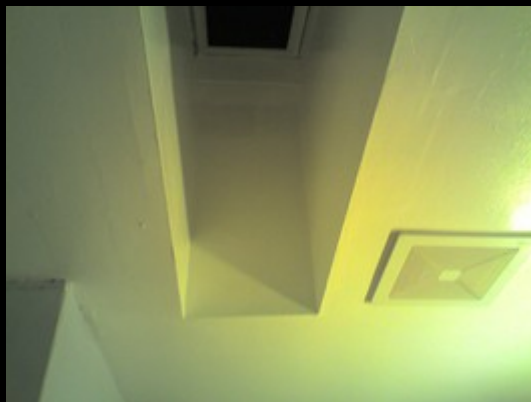
Image Number:	914
Location:	1 st Floor Bathroom
Description/Findings:	Uninsulated skylight knee wall
Suggestions:	Insulate and encapsulate skylight knee wall insulation

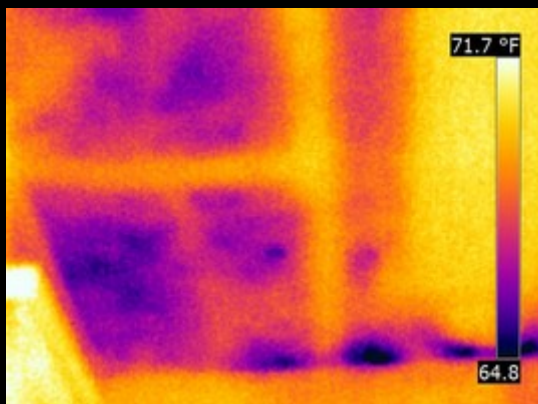
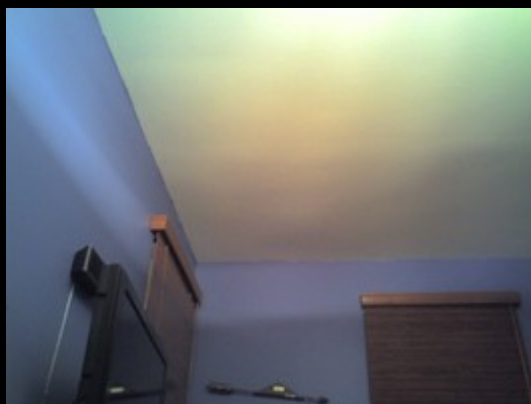
Image Number:	918
Location:	1 st Floor Bedroom – Son
Description/Findings:	Missing insulation in attic
Suggestions:	Air seal and insulate attic flat

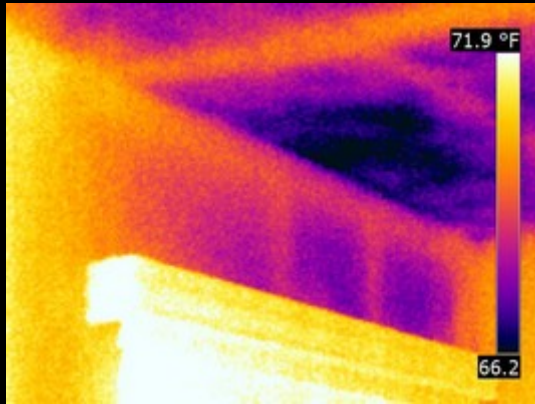
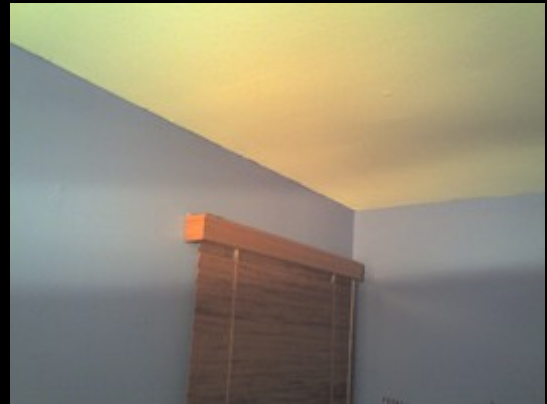
Image Number:	924
Location:	1 st Floor Bedroom – Son
Description/Findings:	Missing insulation observed in attic and above window
Suggestions:	Air seal, insulate, and correct venting of attic flat Insulate exterior walls
